# Manhole Inspection Summary

## Manhole # S13KK\_007MH

Insp Date: **9/5/07 4:48 PM**

**Location** Address: **2100 ASHBURTON ST**

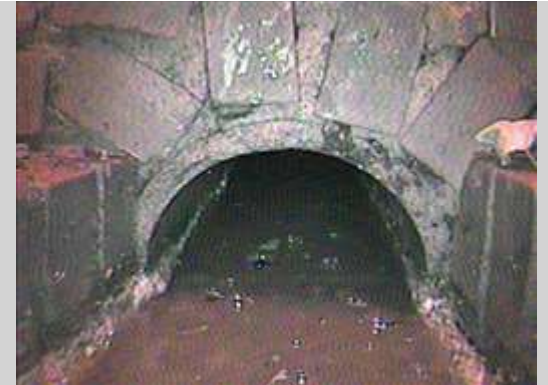
12 O'Clock Outflow

8 in. Circular Gravity Sewer  
Pipe Out @ 12 O'Clock

Pipe Height: (in.) Direct  
Pipe Material: **Clay** ☐ Pipe Lined  
Invert Depth: **9.04** (ft.) Flow Characteristics: **Slow**  
Deposits: ☒ None ☐ Mud ☐ Gravy ☐ Debris ☐ Grease  
Silt Depth: (in.) Deposits Extent:  
Infiltration: **None** Pipe Seal Cond: **Sound**

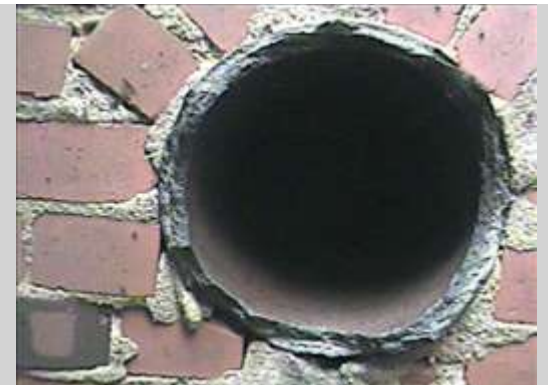
6 O'Clock Inflow

8 in. Circular Gravity Sewer  
Pipe In @ 6 O'Clock

Pipe Height: (in.) Direct  
Pipe Material: **Clay** ☐ Pipe Lined  
Invert Depth: **6.51** (ft.) Flow Characteristics: **Slow**  
Deposits: ☒ None ☐ Mud ☐ Gravy ☐ Debris ☐ Grease  
Silt Depth: (in.) Deposits Extent:  
Infiltration: **None** Pipe Seal Cond: **Sound**

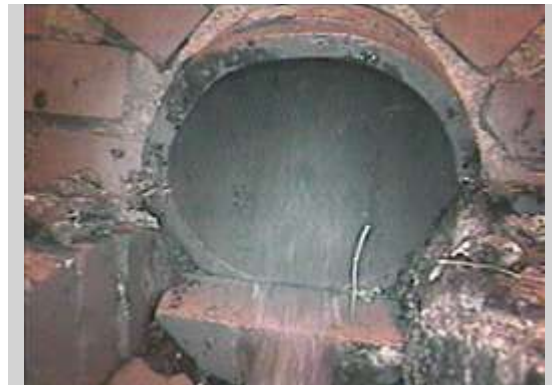
Drop In @ 6 O'Clock

Drop: **Outside Direct**  
Angled: Reading: (ft.)  
Inv Depth: **8.90** (ft.)  
Drop Condition: **Open**

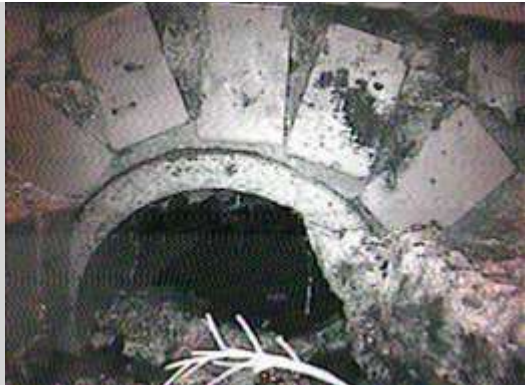
9 O'Clock Inflow

8 in. Circular Gravity Sewer

Pipe In @ 9 O'Clock

Deposits: ☐ None ☐ Mud ☒ **Sludge** ☒ **Debris** ☐ Grease

Silt Depth: **3** (in.) Deposits Extent: **Medium**
